Manhole Inspection Summary

Manhole # S31S1_034MH

Location Address: **928 Bethune Rd.** Cross Street: **Round Rd.**

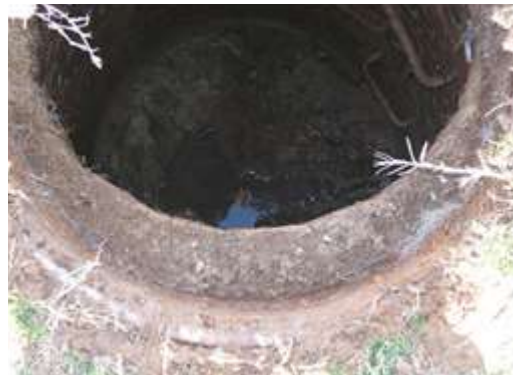
Defect 1

Frame Offset: **4** (in.) Condition: ☒ Sound ☐ Cracked ☐ Leaks

Frame offset

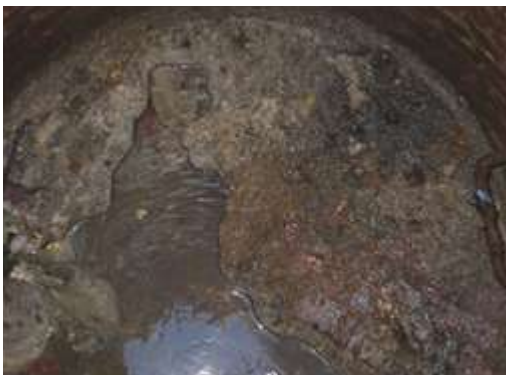
Defect 2

Surcharge ☒ **Evidence Of Surcharge** Depth: **1** (ft.) ☒ **Active Surcharge Present**

Active surcharge

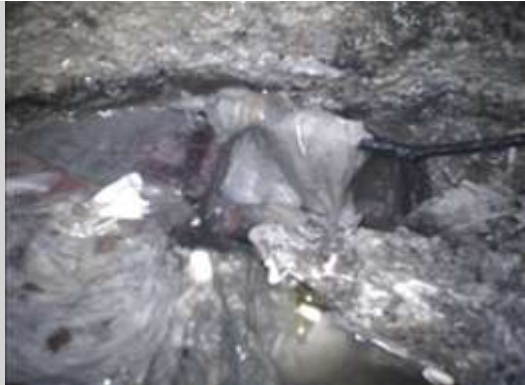
12 O'Clock Outflow

8 in. Circular Gravity Sewer
Pipe Out @ 12 O'Clock

Pipe Height: **8.4** (in.) Rod and Bar (Angled)
Pipe Material: **Clay** ☐ Pipe Lined
Invert Depth: **9.28** (ft.) Flow Characteristics: **Fast**
Deposits: ☒ None ☐ Mud ☐ Sludge ☐ Debris ☐ Grease
Silt Depth: (in.) Deposits Extent:
Infiltration: **None** Pipe Seal Cond: **Unknown**

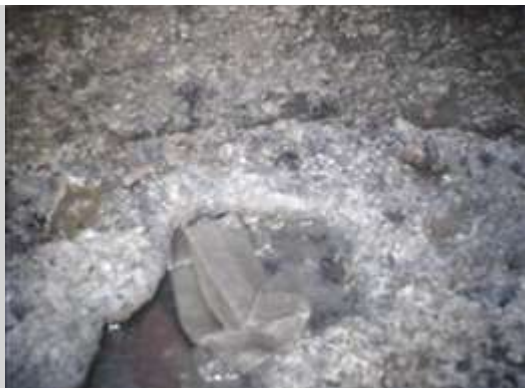
3 O'Clock Inflow

4 in. Circular Gravity Sewer
Pipe In @ 3 O'Clock

Pipe Height: **3.6** (in.) Rod and Bar (Angled)
Pipe Material: **Clay** ☐ Pipe Lined
Invert Depth: **2.00** (ft.) Flow Characteristics: **None**
Deposits: ☒ None ☐ Mud ☐ Sludge ☐ Debris ☐ Grease
Silt Depth: (in.) Deposits Extent:
Infiltration: **None** Pipe Seal Cond: **Unknown**

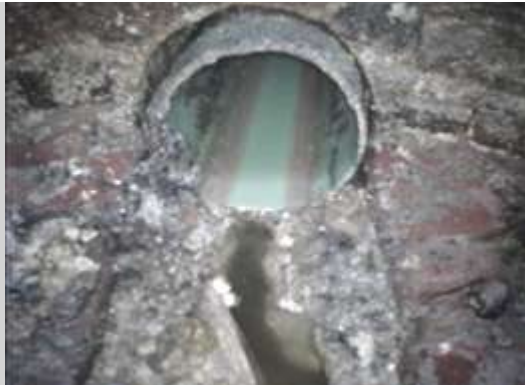
6 O'Clock Inflow

8 in. Circular Gravity Sewer

Pipe In @ 6 O'Clock

Pipe Height: **8.4** (in.) Rod and Bar (Angled)

Pipe Material: **PVC** ☐ Pipe Lined

Invert Depth: **8.69** (ft.) Flow Characteristics: **Slow**

Pipe Seal Cond: **Sound**

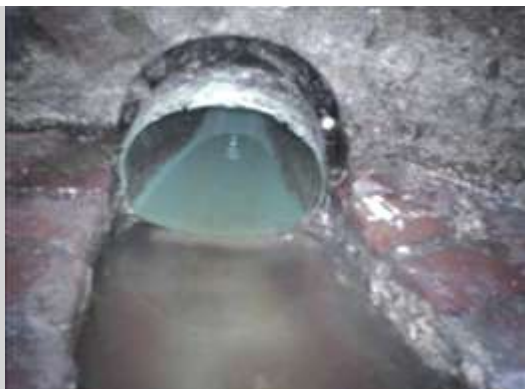
9 O'Clock Inflow

6 in. Circular Gravity Sewer

Pipe In @ 9 O'Clock

Pipe Height: **6** (in.) Rod and Bar (Angled)

Pipe Material: **PVC** ☐ Pipe Lined

Invert Depth: **8.59** (ft.) Flow Characteristics: **Slow**

Pipe Seal Cond: **Sound**
